Manhole Inspection Summary

Manhole # S21CC1019MH

Insp Date: **3/14/07 12:19 PM**

Location Address: **2085 DRUID PARK DR**

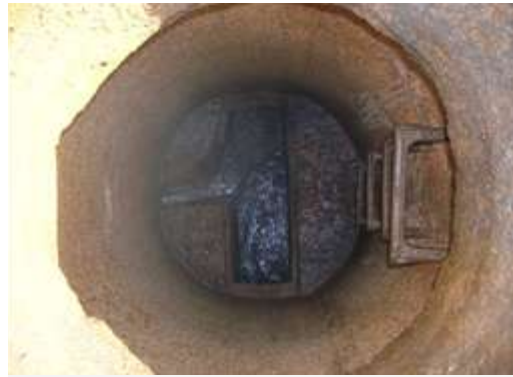
Top View

☒ **Debris** (not Condition related)

Bench debris.

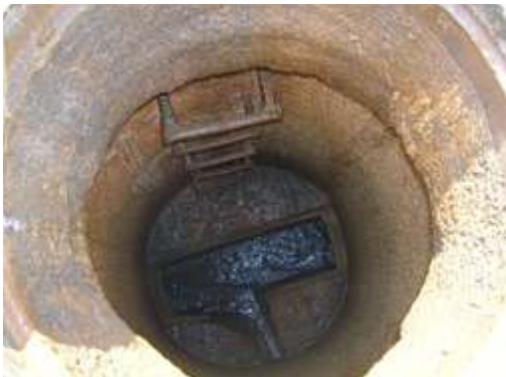
Defect

☒ **Leaks**

Infiltration: ☐ None ☒ **Joint** ☐ Cracks ☐ Mortar ☐ Roots ☐ Wall

Frame leaks. Adjustment infiltration.

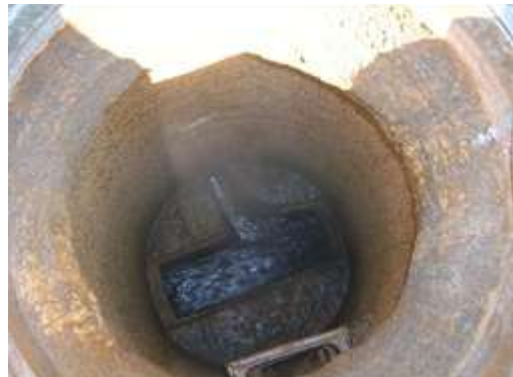
Defect

Frame leaks. Adjustment infiltration - other side.

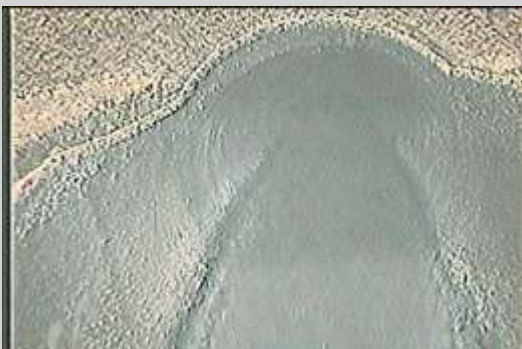
18 in. Circular Gravity Sewer Pipe In @ 6 O'Clock

Deposits: ☐ None ☐ Mud ☐ Sludge ☐ Debris ☒ Grease

Silt Depth: **0** (in.) Deposits Extent: **Light**
